Manhole Inspection Summary

Manhole # S21KK_019MH

Insp Date: **9/29/07 7:54 AM**

Location Address: **1630 RETREAT ST**

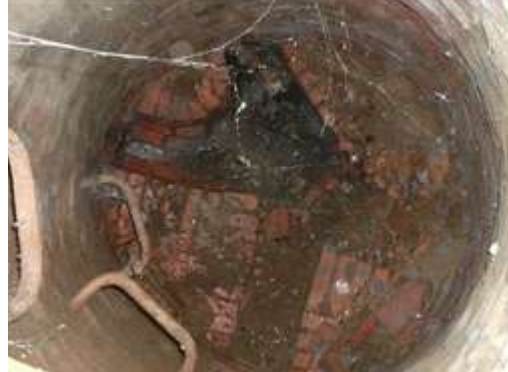
Top View

Corroded steps. Bench and Channel debris.

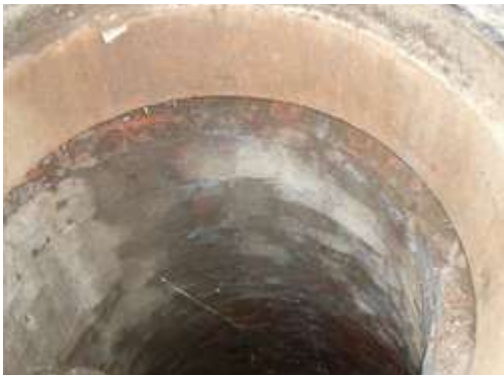
Defect

Frame leaks. Adjustment deterioration and infiltration. Barrel infiltration - other side.

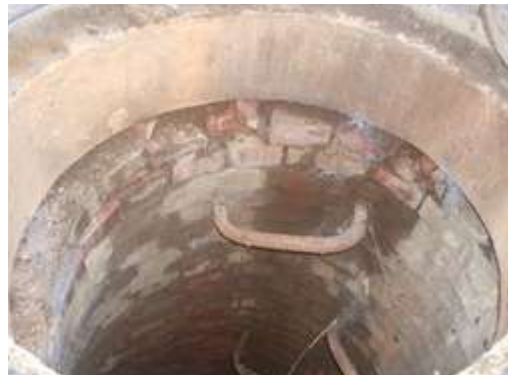
Defect

Frame leaks. Adjustment deterioration and infiltration. Barrel infiltration.

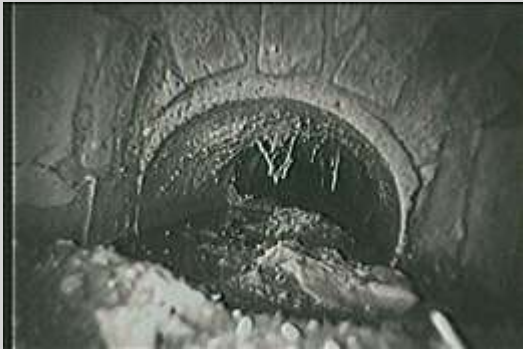
8 in. Circular Gravity Sewer
Pipe Out @ 12 O'Clock

Deposits: ☐ None ☒ **Mud** ☐ Sludge ☒ **Debris** ☐ Grease

Silt Depth: **2** (in.) Deposits Extent: **Light**

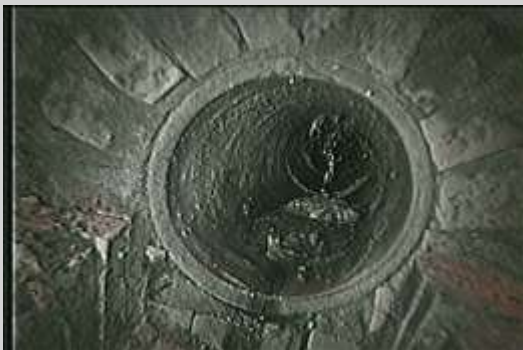
Pipe In @ 9 O'Clock

Deposits: ☐ None ☐ Mud ☐ Sludge ☒ **Debris** ☐ Grease

Infiltration: **Evidence** Pipe Seal Cond: **Roots**
